10,...9,...8,...7,...”Houston, we have launch!

## The Incident....

## The cylinder that got away

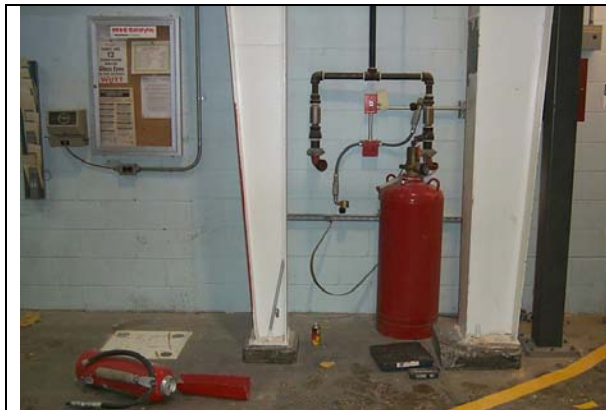
An operator was supposed to remove one of the two FM-200 fire suppression cylinders from service, but things didn't go exactly according to plan. As you can see in the first picture, there's only one of them. During removal of its twin, the cylinder managed to escape and make a clean get away, clear through the ceiling and onto the roof! Look carefully at the second picture and you can identify the need for roof repairs!

Remember this story and the pictures next time you're working with compressed gas cylinders. They have an incredible amount of power - jet power. That's why it's important to practice all those precautions you hear about – keep them chained up, make sure valve covers are in place when moving, follow manufacturer's recommended practices, etc. **And especially, don't allow something to occur which knocks the valve off.** If that happens it could be **“Houston, we have a problem”**.
